Maryland Historical Trust

Maryland Inventory of Historic Properties MHT Number HO-668 Historic Bridge Inventory Maryland State Highway Administration Maryland Historical Trust Name and SHA No. Pindell School Road over Hammond Branch/HO106 Location: Street/Road Name and Number: Pindell School Road City/Town: Columbia Vicinity x County: Howard Ownership: ___State_x_County___Municipal___Other This bridge projects over: ___Road___Railway_x_Water__Land Is the bridge located within a designated district: yes x no __NR listed district__NR determined eligible district _locally designated__other Name of District **Bridge Type:** __Timber Bridge __Beam Bridge__Truss-Covered__Trestle Timber-and-Concrete Stone Arch __Metal Truss _Movable Bridge __Swing __Bascule Single Leaf__Bascule Multiple Leaf __Vertical Lift __Retractile__Pontoon x Metal Girder x Rolled Girder __Rolled Girder Concrete Encased __Plate Girder __Plate Girder Concrete Encased

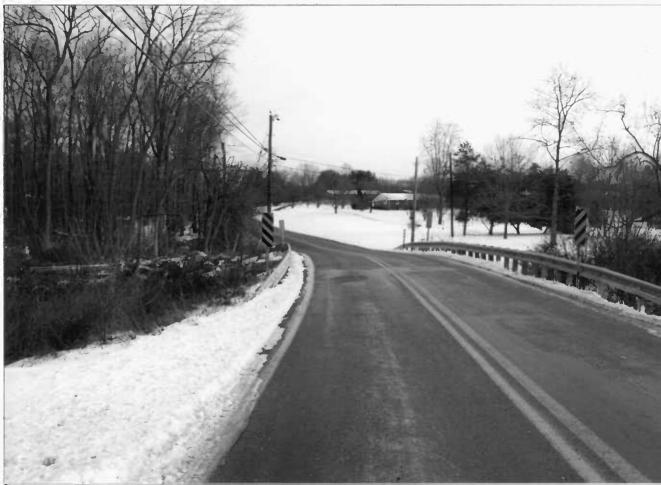
Inventory # <u>#0-668</u>

Name HO 106 - PINDELL SCHOOL ROOFE HAMMOND County/State HOWARD / MO
Name of Photographer DAVIO DIEHL
Date 2 95
Location of Negative SHA
Description SouTH APPROAGH LOSKING MORTH
1 4

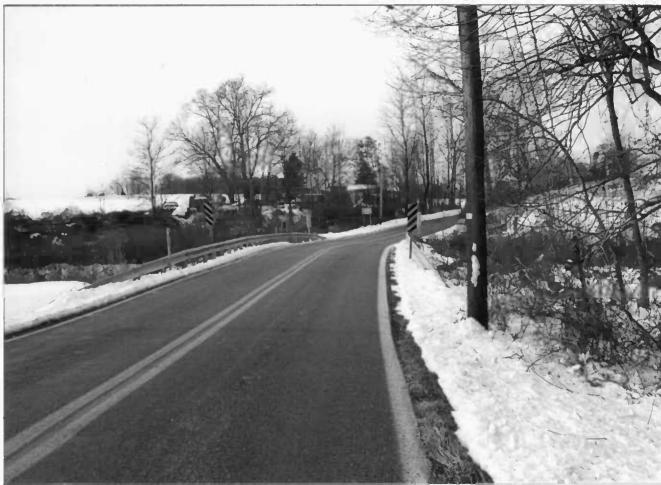
Inventory # <u>Ho-668</u>

Name HOIDLO - PINDELL SCHOOL RD DVER HAMMON	00
County/State Howard Imp	
Name of Photographer DAVID OIERL	
Date 295	
Location of Negative SHA	
Description NORTH APPROACH LOOKING SOUT	H
Number of of

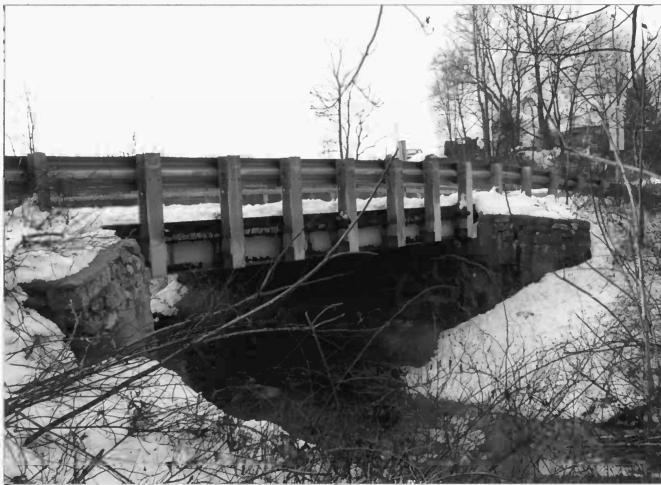
Inventory # 40-668

Name HOIDE-PINDELL SCHOOL RD OVER HAMMOND
County/State Howard Imp
Name of Photographer DAVID DIEHL
Date 2 95
t
Location of Negative SHR
Description WEST ELEVATION LOOKING SOUTH
Number of 33

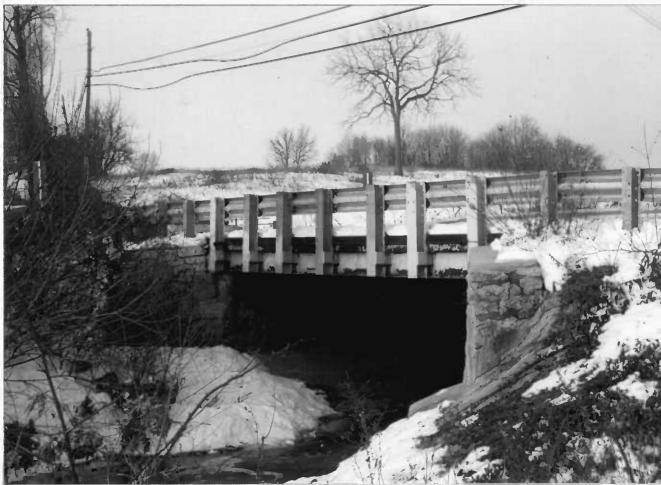
Inventory # <u>H6-668</u>

Name HOLDE-PINDELL SCHOOL ROOMER HAMMOND
County/State Howard mp
Name of Photographer DAVID DIEHL
Date 2 95
Location of Negative SHR
Description EAST ELEVATION LOOKING WEST
A A
Number 30 of 32
